Manhole Inspection Summary

Manhole # S53M__004MH

Insp Date: **3/7/08 2:03 PM**

Location Address: **3218 bouldon**

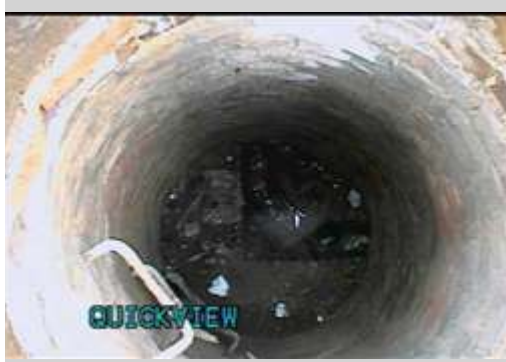
Defect 1

Condition: ☐ Sound ☐ Cracked ☐ Root Intrusion ☐ Loose Brick ☒ **Deteriorated**

Steps Count: **5** Missing: **1** ☒ **Corroded**

corroded and missing steps, deteriorating corbel

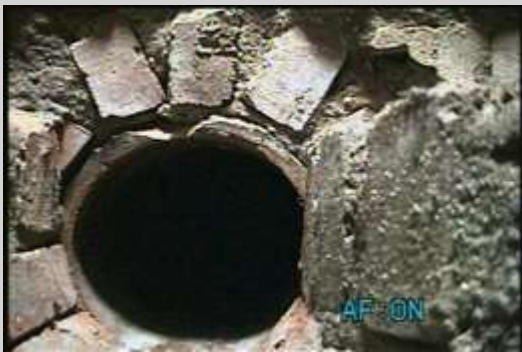
12 O'Clock Outflow

8 in. Circular Gravity Sewer
Pipe Out @ 12 O'Clock

Pipe Material: **Clay** ☐ Pipe Lined

Invert Depth: **10.75** (ft.) Flow Characteristics: **Slow**

Infiltration: **None** Pipe Seal Cond: **Unknown**

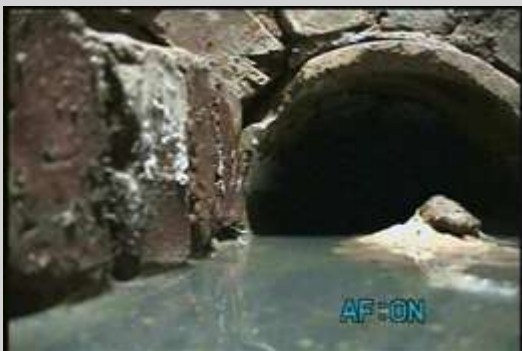
3 O'Clock Inflow

8 in. Circular Gravity Sewer
Pipe In @ 3 O'Clock

Pipe Material: **Clay** ☐ Pipe Lined

Invert Depth: **10.25** (ft.) Flow Characteristics: **Slow**

Infiltration: **None** Pipe Seal Cond: **Unknown**
